Location CHORHAM ROAD ON ROUNDABOUT WITH UPPER CHORHAM ROAD

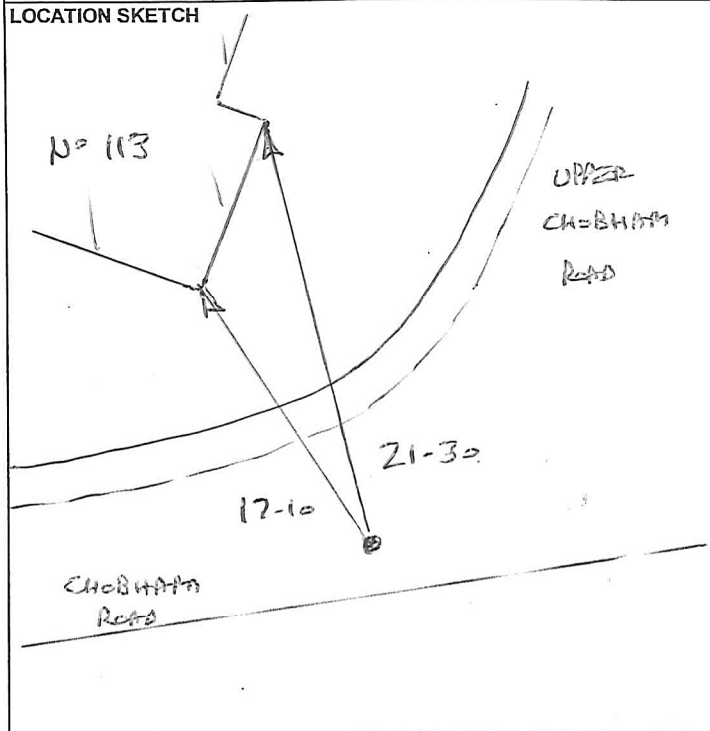
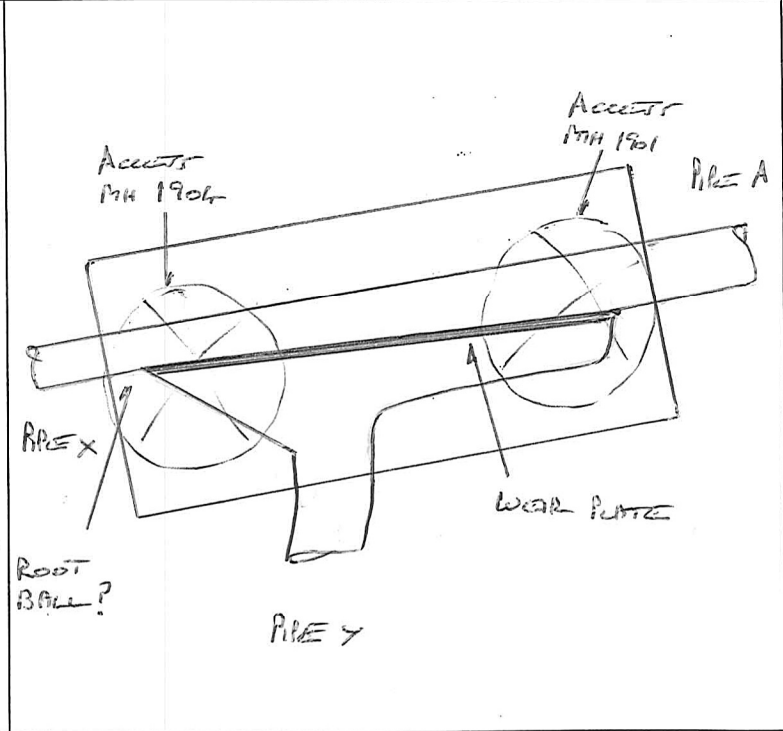
REMARKS
 TWO ACCESS POINTS OF OVERFLOW - BIFURCATION. - PIPE X BLOCKED WITH SILT AND POSSIBLE ROOTS. - ALL FLOW OVER WEAR PLATE. WEAR LENGTH 2660MM - WEAR DEPTH 1.71 M
