Dene-Tech Services Ltd
 Medstead, Alton
 Hampshire, GU34 5EW
 Tel: 01420 562569, Fax:

Inspection report

Road: Road	Division:	start MH: W10-12
Place: Place	District:	end MH: W10-11
Location:	Tape No.: 1	Total length: 11.4 m
Purpose: Asset condition	Size/Shape: Rectangular 570/1110	
Use: Watercourse	Material: Brick Pipe length:	
Catchment:	Lining:	
	Category:	
Comment:		
Location details:

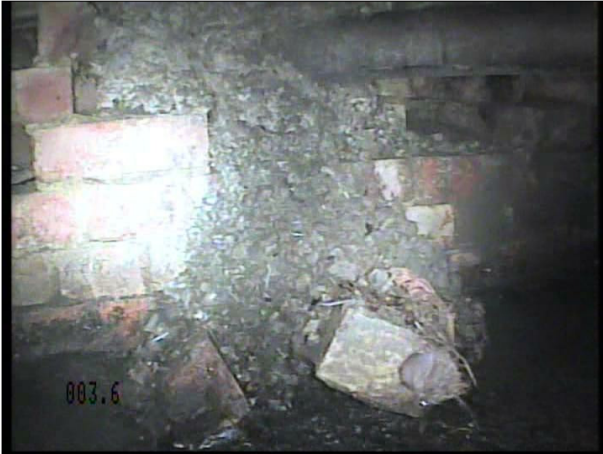
0.00	S2	MM Mortar missing medium from 01 to 04 o'clock, Start			
	0.00	S3	DES Debris silt, 5 % cross-sectional area loss, Start			(Serv) 1
	1.50	OB	Obstruction, 5 % height/diameter loss		2_6a	(Serv) 2

Photo: 2_6a, Tape No.: 1
 1.5m, Obstruction, 5 % height/diameter loss

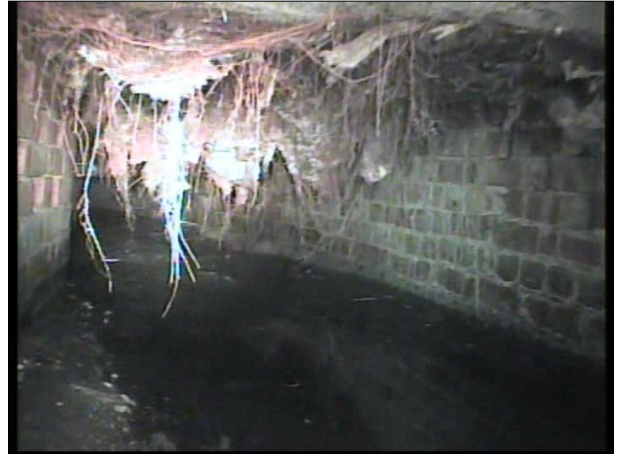
13.50	CN	Connection, at 10 o'clock, dia 100 mm. Enclosed Pipe			(Constr) 0
	13.80	CN	Connection, at 10 o'clock, dia 100 mm. Enclosed Pipe			(Constr) 0
	23.50	RM	Mass Roots 10 % cross-sectional area loss		2_15a	(Serv) 5

Photo: 2_15a, Tape No.: 1
 23.5m, Mass Roots 10 % cross-sectional area loss

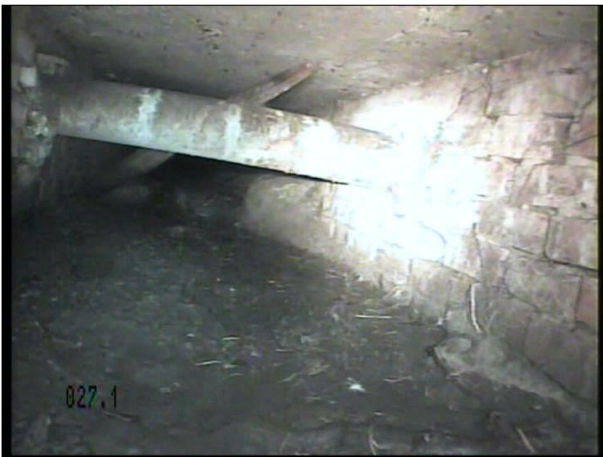
24.00	S4	LL Line of Sewer deviates left, Start			(Serv) 0
	25.00	F4	LL Line of Sewer deviates left, Finish			(Serv) 0
	28.20	CN	Connection, at 10 o'clock, dia 150 mm. Enclosed Pipe		2_18a	(Constr) 0

Photo: 2_18a, Tape No.: 1
 28.2m, Connection, at 10 o'clock, dia 150 mm. Enclosed Pipe

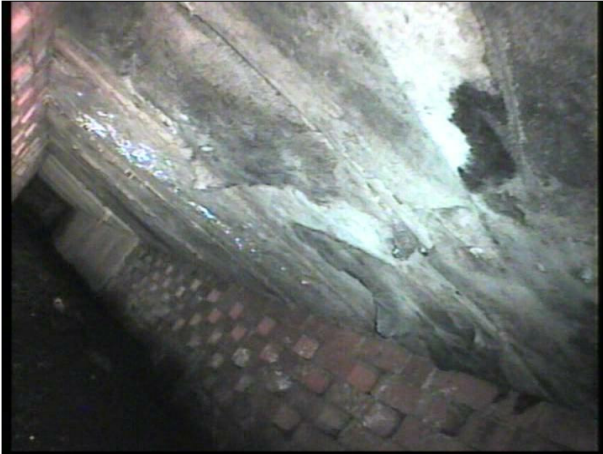
13.50	OB	Obstruction, 5 % height/diameter loss. Brick			(Serv) 2
	18.10	SW	Surface damage wear from 10 to 02 o'clock		3_8a	(Struct) 2
	23.30	LL	Line of Sewer deviates left			(Serv) 0

Photo: 3_8a, Tape No.: 1
18.1m, Surface damage wear from 10 to 02 o'clock

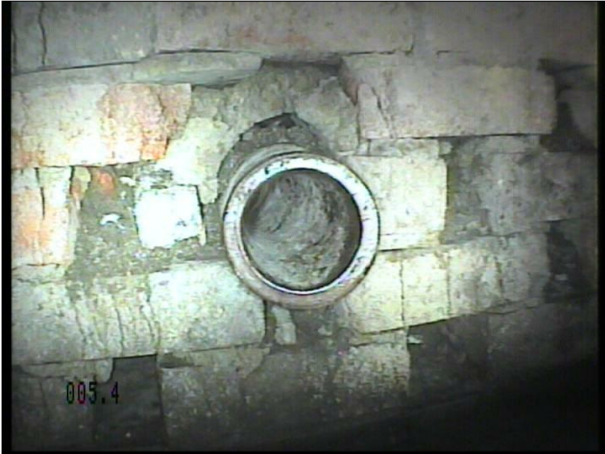
0.00	S2	MM Mortar missing medium from 07 to 11 o'clock, Start			
	0.00	S3	DES Debris silt, 5 % cross-sectional area loss, Start			(Serv) 1
	5.40	CNI	Connection, at 09 o'clock, dia 100 mm, intrusion 50 mm		8_6a	(Constr) 4

Photo: 8_6a, Tape No.: 1
5.4m, Connection, at 09 o'clock, dia 100 mm, intrusion 50 mm

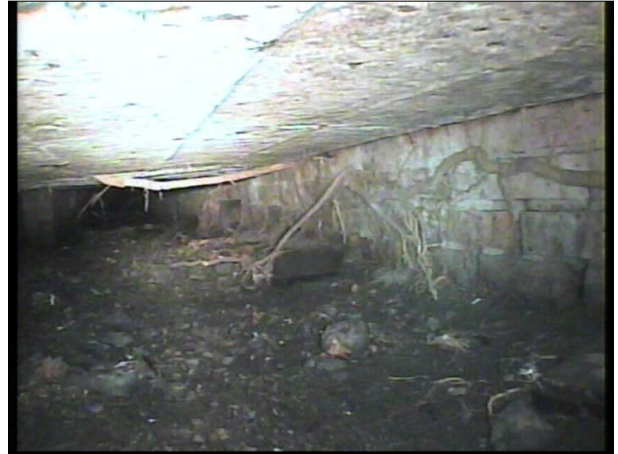
20.00	S4	DE Debris, 20 % cross-sectional area loss, Start			(Serv) 1
	27.60	RT	Tap Roots		8_11a	(Serv) 3
	27.60	F4	DE Debris, 20 % cross-sectional area loss, Finish			(Serv) 1

Photo: 8_11a, Tape No.: 1
27.6m, Tap Roots

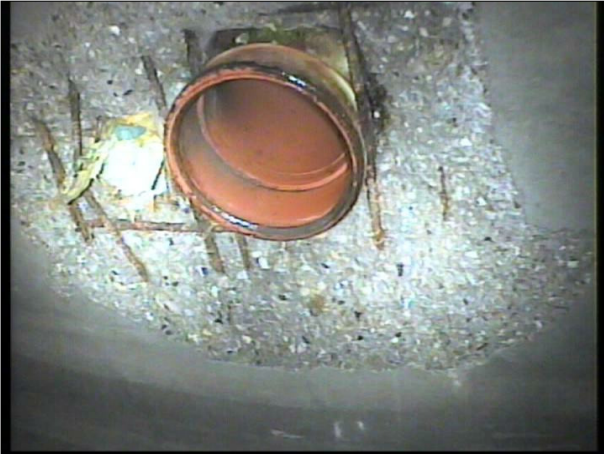
1.90	S2	CN	Connection, at 01 o'clock, dia 80 mm, Start		(Constr) 0
	3.70	CN	Connection, at 12 o'clock, dia 150 mm			(Constr) 0
	3.70	SSS	Surface damage, spalling slight, from 12 to 01 o'clock	9_6a		(Struct) 2

Photo: 9_6a, Tape No.: 1
3.7m, Surface damage, spalling slight, from 12 to 01 o'clock

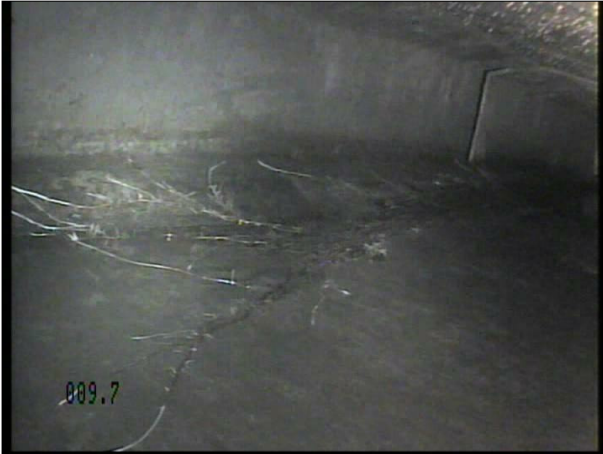
Photo: 10_7a, Tape No.: 1
9.7m, Tap Roots

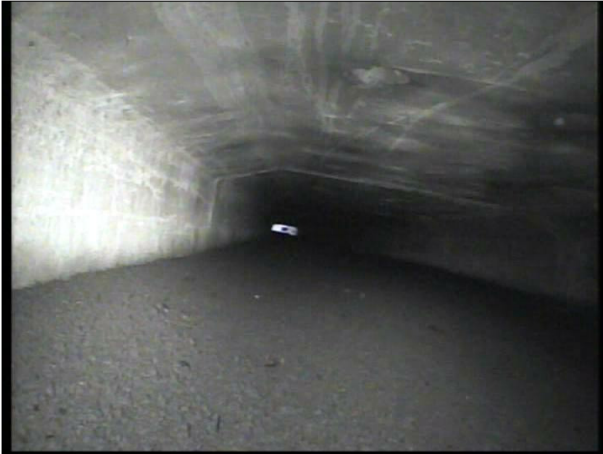
Photo: 14_7a, Tape No.: 1
7.6m, Survey abandoned

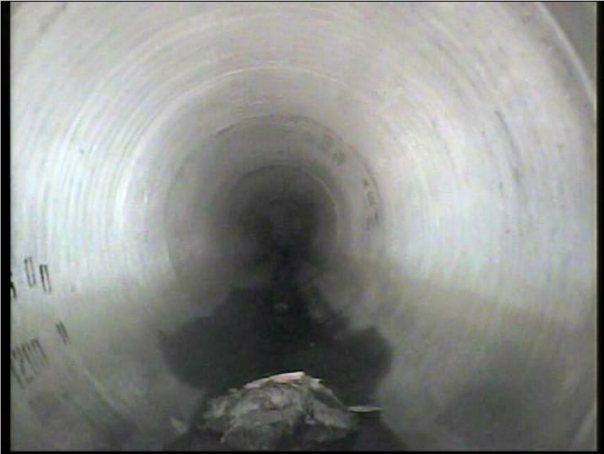
Photo: 15_4a, Tape No.: 1
10.1m, Obstruction, 5 % height/diameter loss

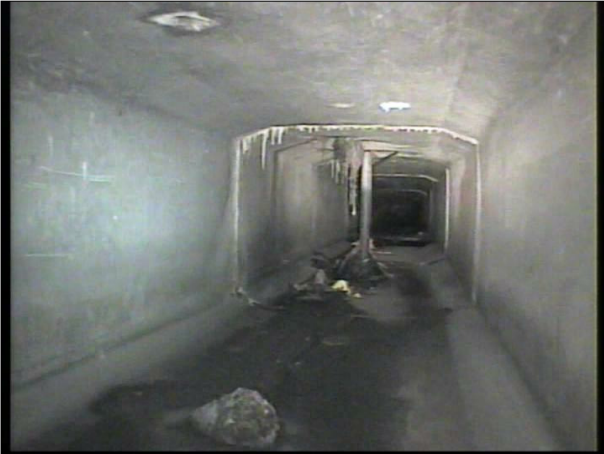
Photo: 16_5a, Tape No.: 1
 12.8m, Obstruction, 5 % height/diameter loss

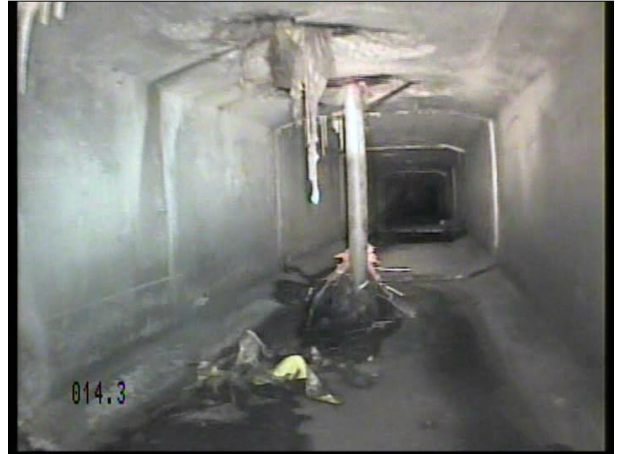
Photo: 16_6a, Tape No.: 1
 15.5m, Obstruction, 10 % height/diameter loss

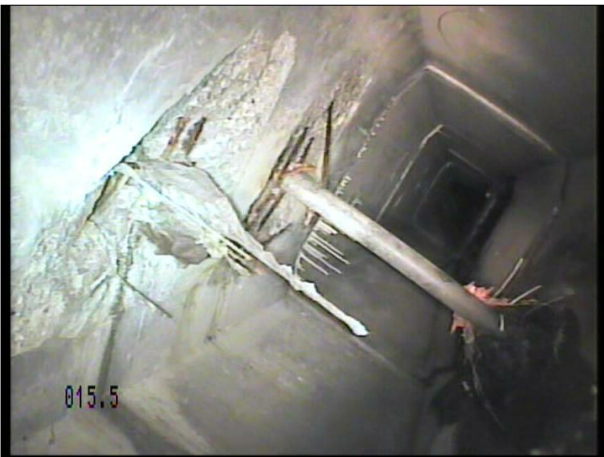
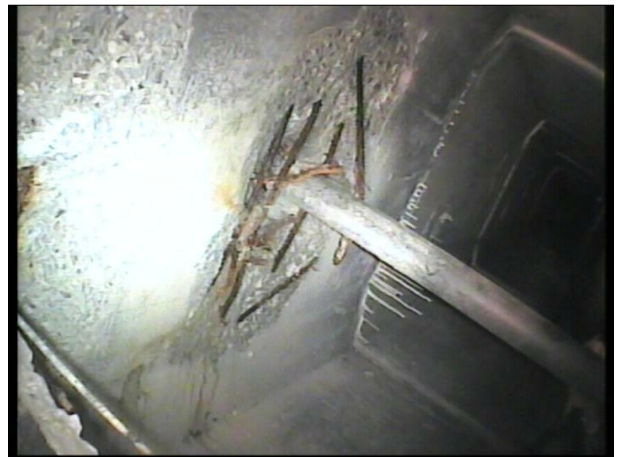
Photo: 16_7a, Tape No.: 1
 15.5m, Surface damage, spalling medium, at 12 o'clock

Photo: 16_7b, Tape No.: 1
 15.5m, Surface damage, spalling medium, at 12 o'clock

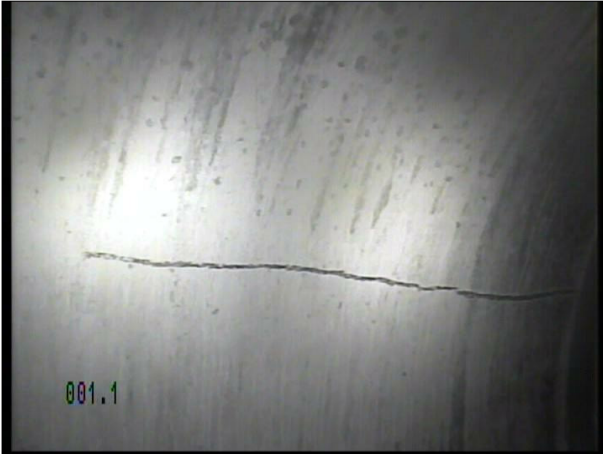
1:300	position	code	observation	MPEG	photo	grade
	0.00	ST	Start of Survey			(Misc) 0
	0.00	MH	Manhole Remark: W10-3			(Constr) 0
	0.00	S1 DES	Debris silt, 5 % cross-sectional area loss, Start			(Serv) 1
	1.10	CL	Longitudinal Crack, at 11 o'clock		17_4a	(Struct) 2
	40.00	MH	Manhole Remark: W10-4			(Constr) 0
	40.00	F1 DES	Debris silt, 5 % cross-sectional area loss, Finish			(Serv) 1
	40.00	FH	Finish Survey			(Misc) 0

Photo: 17_4a, Tape No.: 1
1.1m, Longitudinal Crack, at 11 o'clock

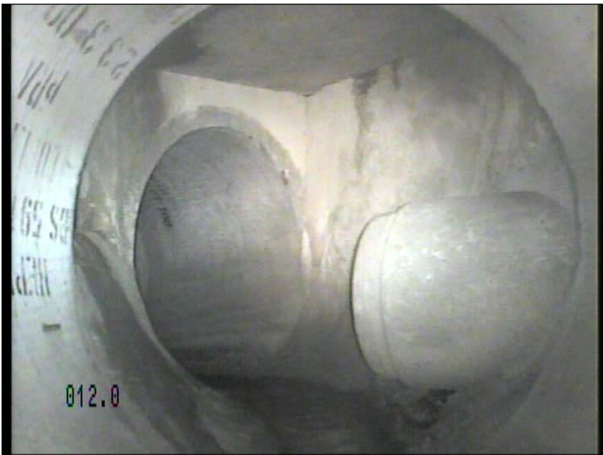
Photo: 19_3a, Tape No.: 1
12.5m, Connection, at 03 o'clock, dia 225 mm, intrusion 300 mm
