Project name:
Project Name CCTV

Contract number:
Job No

Contractor	Dene-Tech Services Ltd
Contact:	Richard Nash
Position:	Unit 10 Lymington Barn
Road	Lymington Bottom Road
Town	Medstead, Alton
County	Hampshire, GU34 5EW
Telephone:	01420 562569
Fax:	
Mobile:	
E-Mail:	Richard@denetech.co.uk

Inspection report

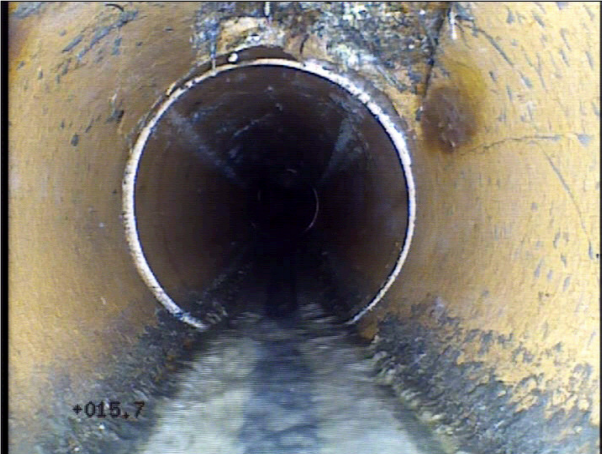
1:150	position	code	observation	MPEG	photo	grade
	SK61014306	0.00	ST Start of Survey			(Misc) 0
		0.00	MH Manhole Remark: SK61014306			(Constr) 0
		0.00	WL Water level, 10 % height/diameter			(Serv) 0
		15.70	H Hole in sewer from 12 to 02 o'clock		14a	(Struct) 4
	SK61014307	18.30	MH Manhole Remark: SK61014307			(Constr) 0
		18.30	FH Finish Survey			(Misc) 0

Photo: 14a, Tape No.: 3
15.7m, Hole in sewer from 12 to 02 o'clock

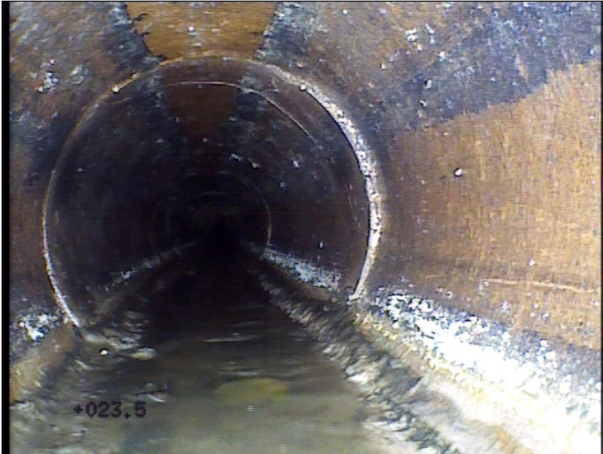
Photo: 36a, Tape No.: 7
23.5m, Circumferential Crack at joint, from 11 to 04 o'clock

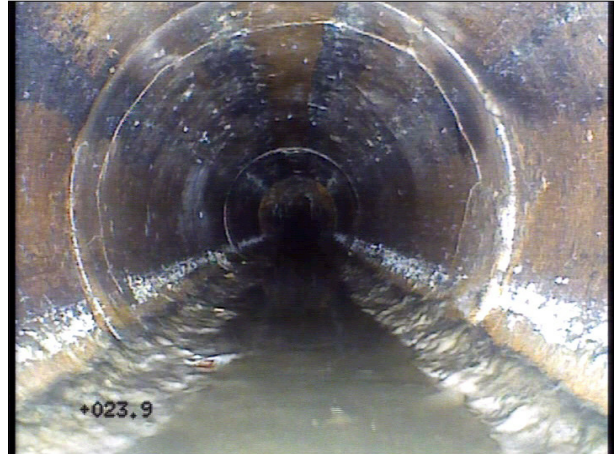
Photo: 37a, Tape No.: 7
23.9m, Circumferential Crack at joint, from 07 to 04 o'clock

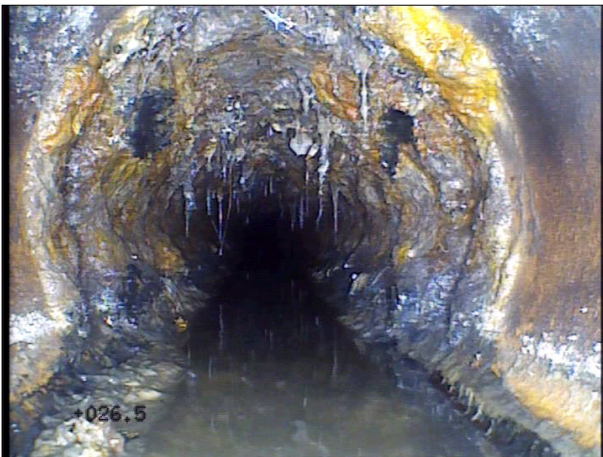
Photo: 38a, Tape No.: 7
25.8m, Encrustation medium, from 07 to 05 o'clock,
cross-sectional area loss
