Project-information

Project name:
Project Name CCTV

Inspection report

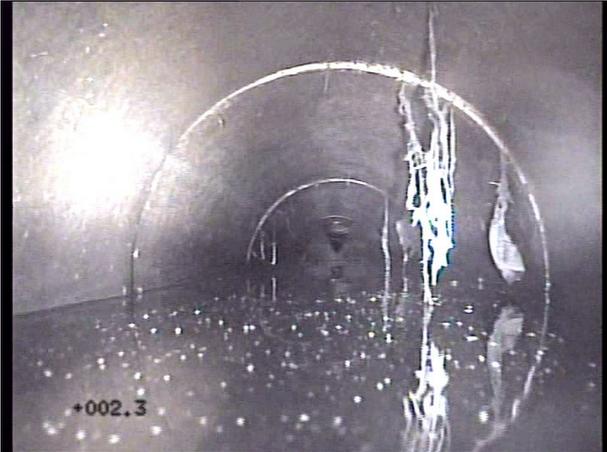
Photo: 4a, Tape No.: 1
2.3m, Fine Roots at joint

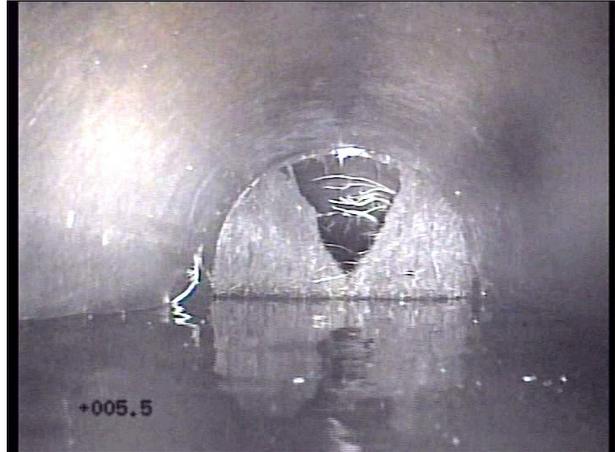
Photo: 5a, Tape No.: 1
5.5m, Mass Roots at joint 50 % cross-sectional area loss

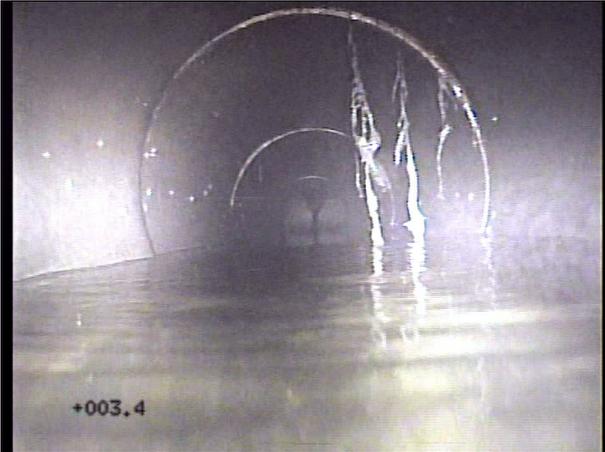
Photo: 19a, Tape No.: 3
3.4m, Fine Roots at joint, Start

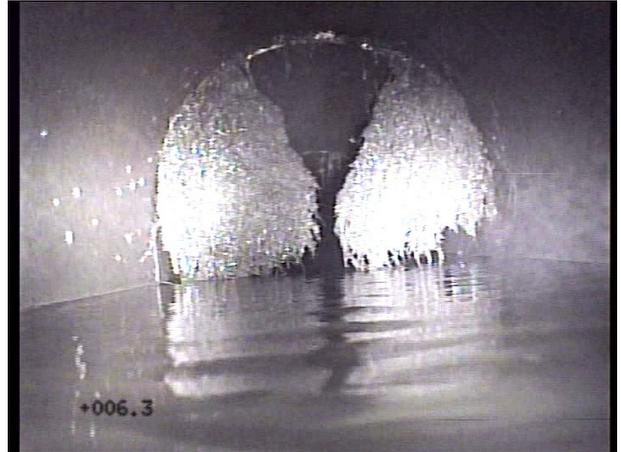
Photo: 20a, Tape No.: 3
6.3m, Mass Roots at joint 45 % cross-sectional area loss

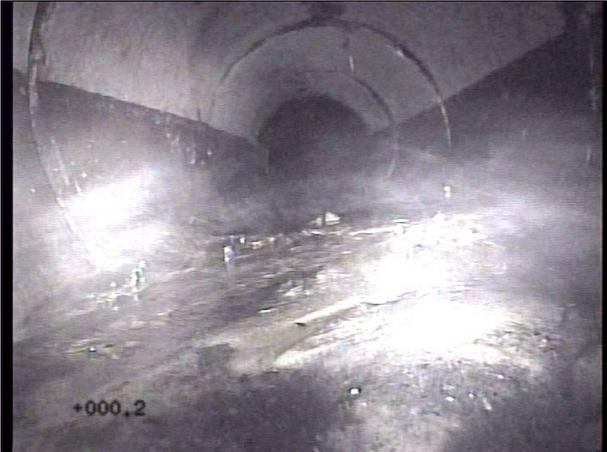
Photo: 30a, Tape No.: 4
0.2m, Debris, 20 % cross-sectional area loss, Start

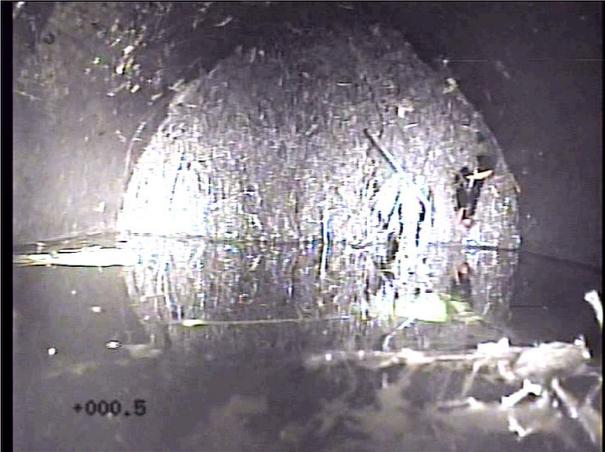
Photo: 37a, Tape No.: 5
0.5m, Mass Roots at joint 95 % cross-sectional area loss

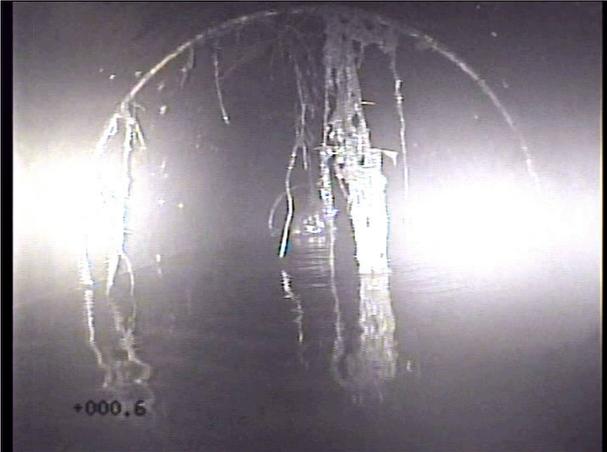
Photo: 41a, Tape No.: 6
0.6m, Fine Roots at joint

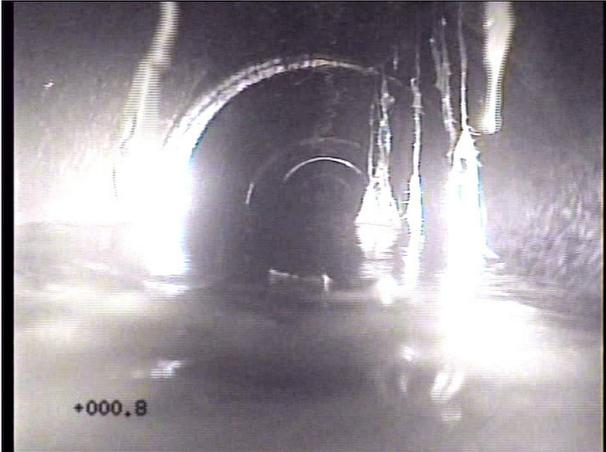
Photo: 52a, Tape No.: 7
0.8m, Fine Roots at joint, Start

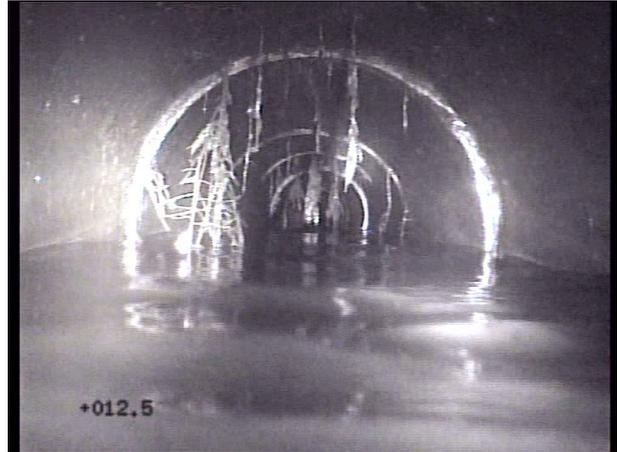
Photo: 56a, Tape No.: 7
12.5m, Fine Roots at joint, Start

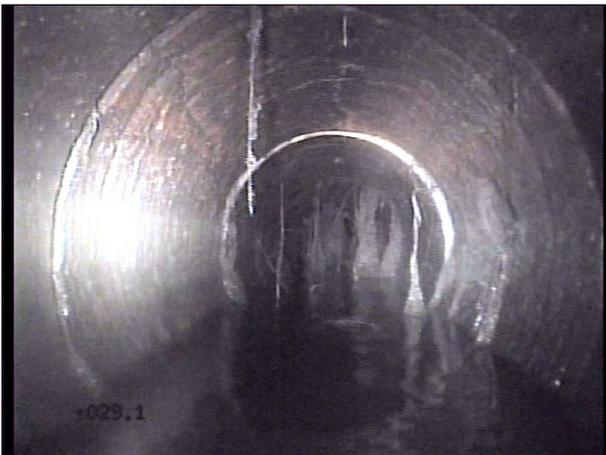
Photo: 58a, Tape No.: 7
29.1m, Hole in sewer at 03 o'clock

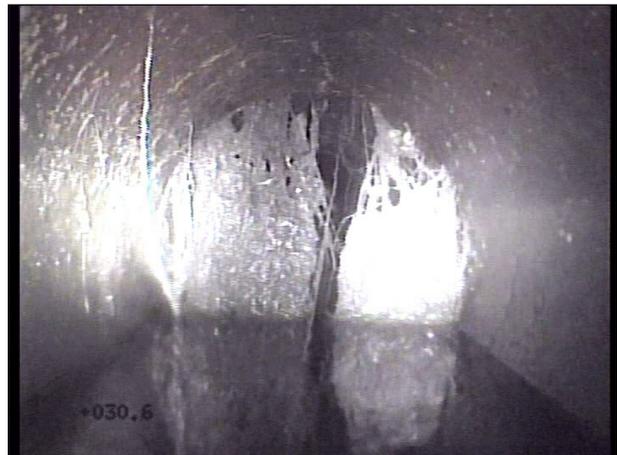
Photo: 59a, Tape No.: 7
30.6m, Mass Roots at joint 80 % cross-sectional area loss

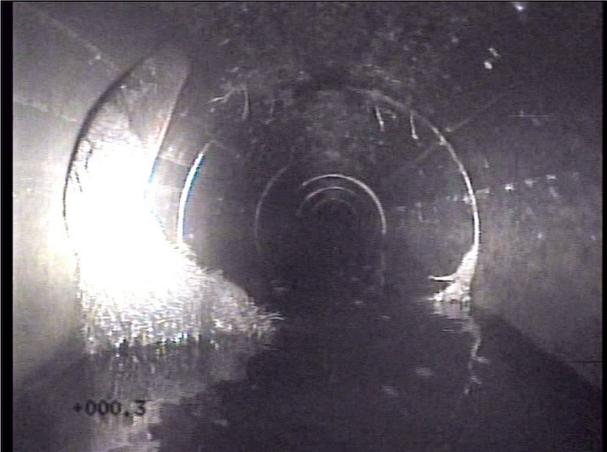
Photo: 65a, Tape No.: 8
0.3m, Mass Roots 20 % cross-sectional area loss

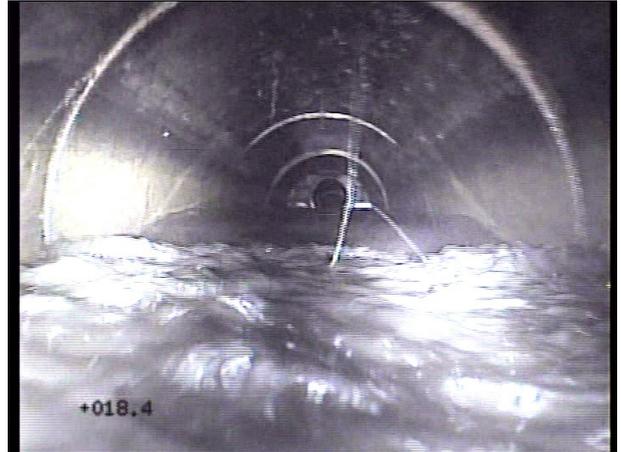
Photo: 69a, Tape No.: 8
18.4m, Debris, 50 % cross-sectional area loss, Change

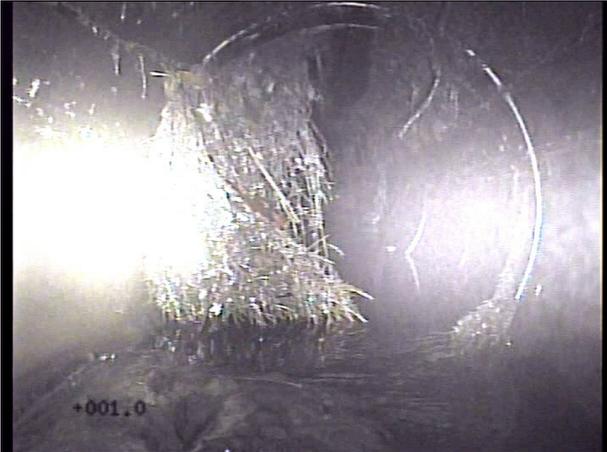
Photo: 76a, Tape No.: 9
1m, Fine Roots at joint

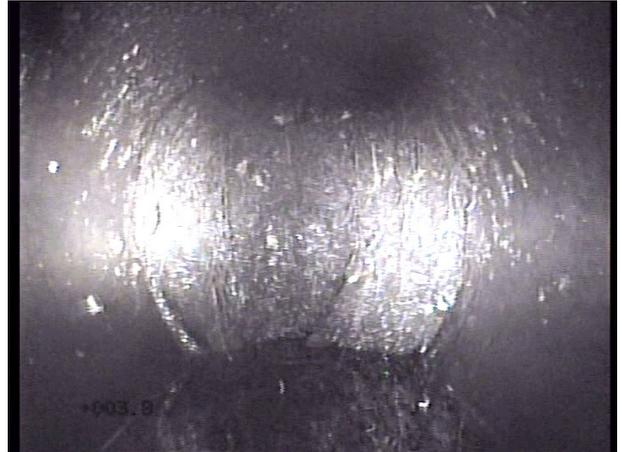
Photo: 77a, Tape No.: 9
3.8m, Mass Roots at joint 95 % cross-sectional area loss
