Dene-Tech Services Ltd
 Medstead, Alton
 Hampshire, GU34 5EW
 Tel: 01420 562569, Fax:

Inspection report

Road: Road	Division:	start MH: W10-12
Place: Place	District:	end MH: W10-11
Location:	Tape No.: 1	Total length: 11.4 m
Purpose: Asset condition	Size/Shape: Rectangular 570/1110	
Use: Watercourse	Material: Brick Pipe length:	
Catchment:	Lining:	
	Category:	
Comment:		
Location details:

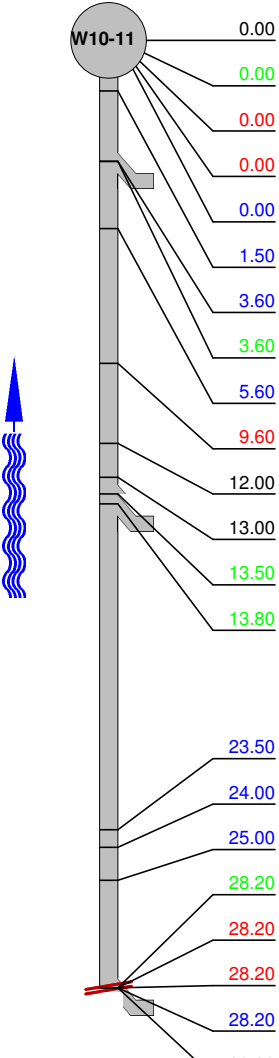
1:225	position	code	observation	MPEG	photo	grade

0.00	ST	Start of Survey			(Misc) 0
	0.00	MH	Manhole Remark: W10-11			(Constr) 0
	0.00	S1	MM Mortar missing medium from 08 to 11 o'clock, Start

0.00	S2	MM Mortar missing medium from 01 to 04 o'clock, Start			
	0.00	S3	DES Debris silt, 5 % cross-sectional area loss, Start			(Serv) 1
	1.50	OB	Obstruction, 5 % height/diameter loss		2_6a	(Serv) 2

9.60	MB	Missing bricks from 08 to 09 o'clock			
	12.00	DC	Dimension of sewer changes, new dimension 450x1110mm			(Misc) 0
	13.00	DC	Dimension of sewer changes, new dimension 570x1110mm			(Misc) 0

28.20	F1	MM Mortar missing medium from 08 to 11 o'clock, Finish			
	28.20	F2	MM Mortar missing medium from 01 to 04 o'clock, Finish			
	28.20	F3	DES Debris silt, 5 % cross-sectional area loss, Finish			(Serv) 1

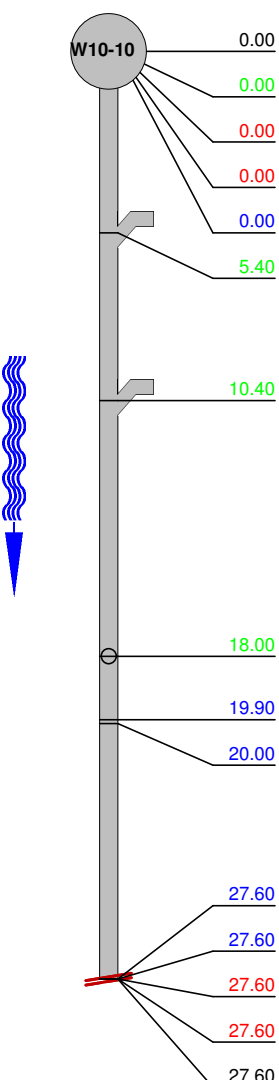
1:225	position	code	observation	MPEG	photo	grade

0.00	ST	Start of Survey			(Misc) 0
	0.00	MH	Manhole Remark: W10-10			(Constr) 0
	0.00	S1	MM Mortar missing medium from 01 to 05 o'clock, Start

0.00	S2	MM Mortar missing medium from 07 to 11 o'clock, Start			
	0.00	S3	DES Debris silt, 5 % cross-sectional area loss, Start			(Serv) 1
	5.40	CNI	Connection, at 09 o'clock, dia 100 mm, intrusion 50 mm		8_6a	(Constr) 4

27.60	F1	MM Mortar missing medium from 01 to 05 o'clock, Finish			
	27.60	F2	MM Mortar missing medium from 07 to 11 o'clock, Finish			
	27.60	SA	Survey abandoned. Camera Stuck			(Misc) 0

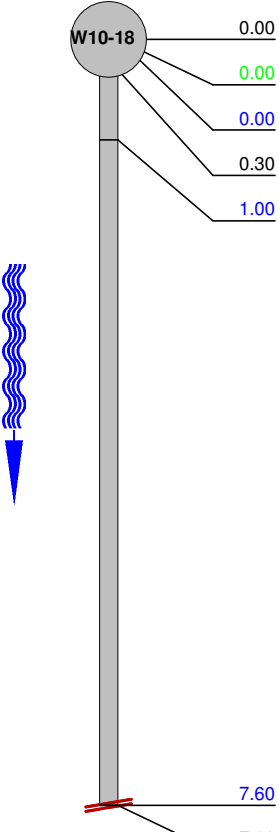
1:75	position	code	observation	MPEG	photo	grade

0.00	ST	Start of Survey			(Misc) 0
	0.00	MH	Manhole Remark: W10-18			(Constr) 0
	0.00	S1 DES	Debris silt, 30 % cross-sectional area loss, Start			(Serv) 1
	0.30	DC	Dimension of sewer changes, new dimension 350x1300mm			(Misc) 0
	1.00	OB	Obstruction, 5 % height/diameter loss			(Serv) 2
	7.60	F1 DES	Debris silt, 30 % cross-sectional area loss, Finish			(Serv) 1
	7.60	SA	Survey abandoned		14_7a	(Misc) 0
