Project name:
Project Name CCTV

Contract number:
Job No

Contractor	Dene-Tech Services Ltd
Contact:	Richard Nash
Position:	Unit 10 Lymington Barn
Road	Lymington Bottom Road
Town	Medstead, Alton
County	Hampshire, GU34 5EW
Telephone:	01420 562569
Fax:	
Mobile:	
E-Mail:	Richard@denetech.co.uk

Inspection report

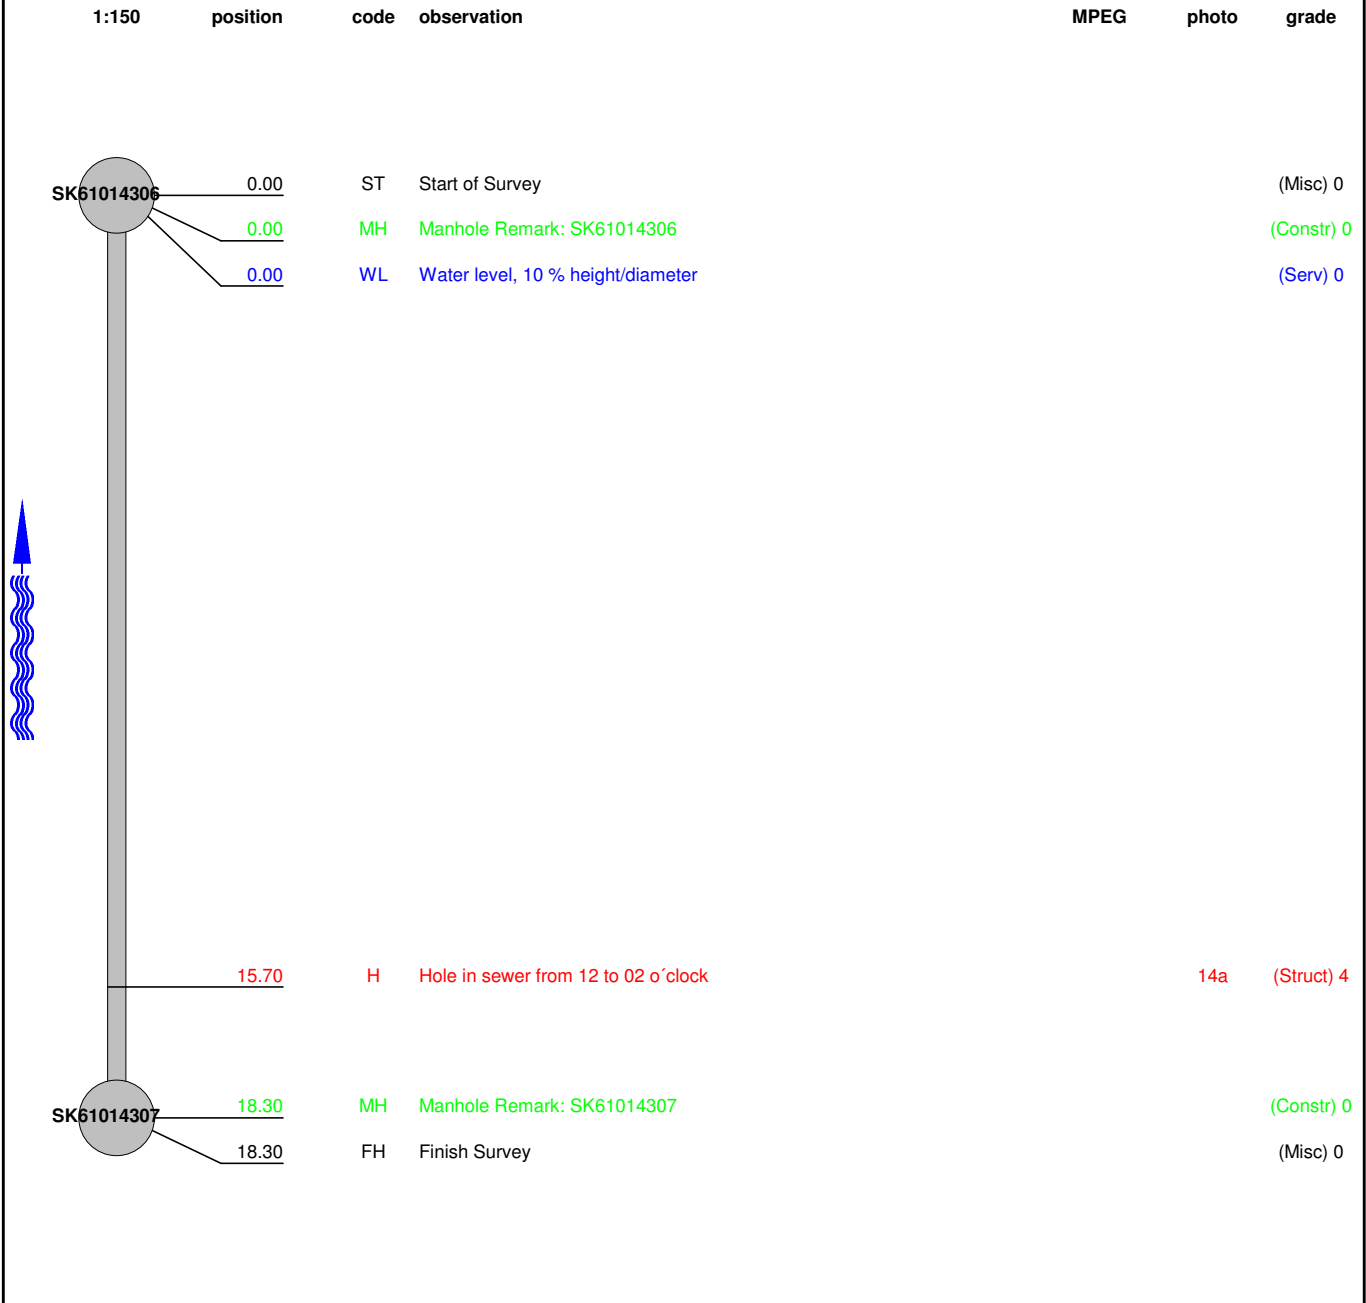
1:150	position	code	observation	MPEG	photo	grade
	SK61014306	0.00	ST Start of Survey			(Misc) 0
		0.00	MH Manhole Remark: SK61014306			(Constr) 0
		0.00	WL Water level, 10 % height/diameter			(Serv) 0
		15.70	H Hole in sewer from 12 to 02 o'clock		14a	(Struct) 4
	SK61014307	18.30	MH Manhole Remark: SK61014307			(Constr) 0
		18.30	FH Finish Survey			(Misc) 0

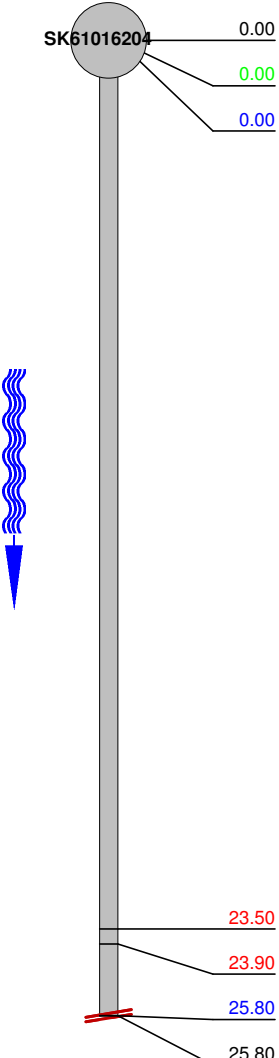
0.00	ST	Start of Survey			(Misc) 0
	0.00	MH	Manhole Remark: SK61016204			(Constr) 0
	0.00	WL	Water level, 5 % height/diameter			(Serv) 0
	23.50	CCJ	Circumferential Crack at joint, from 11 to 04 o'clock	36a		(Struct) 2
	23.90	CCJ	Circumferential Crack at joint, from 07 to 04 o'clock	37a		(Struct) 2
	25.80	EM	Encrustation medium, from 07 to 05 o'clock, cross-sectional area loss	38a		(Serv) 4
	25.80	SA	Survey abandoned			(Misc) 0
