Project-information

Project name:
Project Name CCTV

Inspection report

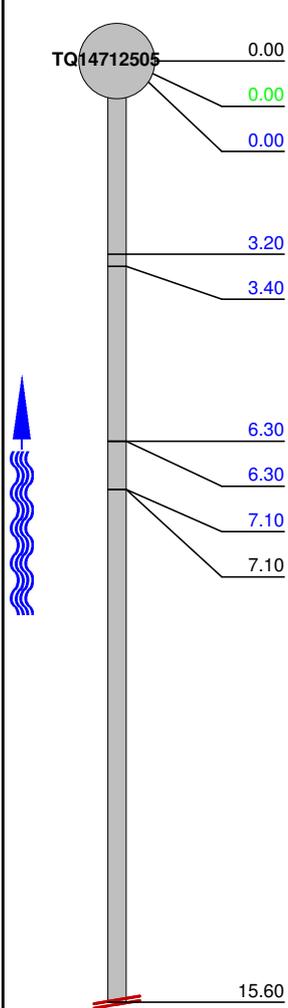
1:125	position	code	observation	MPEG	photo	grade
	0.00	ST	Start of Survey			(Misc) 0
	0.00	MH	Manhole Remark: TQ14712505			(Constr) 0
	0.00	WL	Water level, 10 % height/diameter			(Serv) 0
	3.20	WL	Water level, 20 % height/diameter			(Serv) 0
	3.40	S1 RFJ	Fine Roots at joint, Start		19a	(Serv) 1
	6.30	RMJ	Mass Roots at joint 45 % cross-sectional area loss		20a	(Serv) 5
	6.30	IDJ	Infiltration Dripping at joint from 11 to 01 o'clock			(Serv) 2
	7.10	WL	Water level, 30 % height/diameter			(Serv) 0
	7.10	CU	Camera Underwater, Remark: EVEN AS TANKER SUCKING WATER			(Misc) 0
	15.60	SA	Survey abandoned			(Misc) 0
